**Region 9 Enforcement Division
75 Hawthorne Street
San Francisco, CA 94105**

Inspection Date(s):	9/30/2015		
Time:	Entry: 10:45	Exit: 11:30	
Media:	Water		
Regulatory Program(s)	Clean Water Act NPDES /CAFO Dairy		
Company Name:	SD Farms II		
Facility or Site Name:			
Facility/Site Physical Location:	Ex. 6 Personal Privacy (PP)		
Geographic Coordinates:			
Mailing address:	c/o Heritage Farm Office		
	Ex. 6 Personal Privacy (PP)	CA 90815	
Facility/Site Contact:	Amos DeGroot	Title: Operator	
	Phone: Ex. 6 Personal Privacy (PP)	Email:	
Facility/Site Identifier:	NPDES CAG018001 / Order R8-2013-0001, General waste discharge requirements for CAFOs (dairies and related facilities)		
NAICS:	112120 Dairy Cattle and Milk Production		
SIC:	0241 Dairy Farms		
Facility/Site Personnel Participating in Inspection:			
Name	Affiliation	Title	Email
Nancy Goedhard	SD Farms II	Business Manager	
Simone Leal-lepe	SD Farms II	Facility Manager	
EPA Inspector(s):			
John Tinger	EPA	Engineer	Tinger.John@EPA.gov

SANTA ANA REGIONAL WATER QUALITY CONTROL BOARD
INSPECTION REPORT

SD Farms II

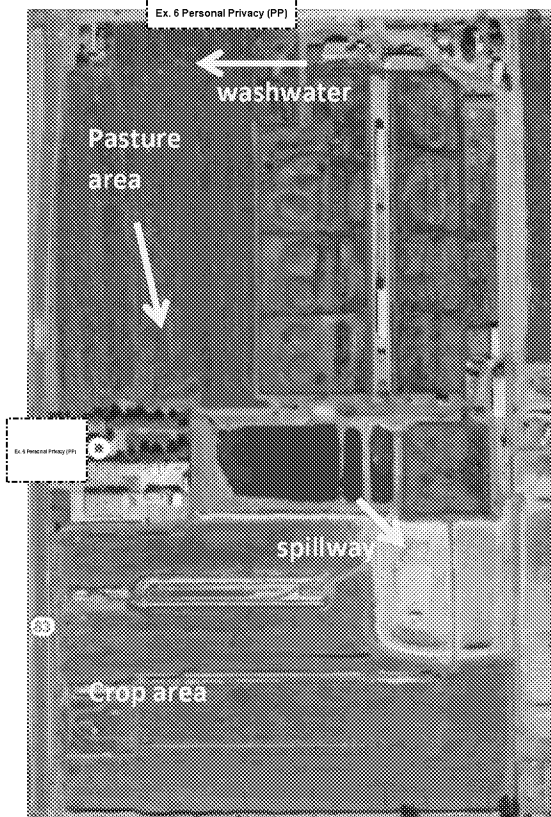
Stormwater from the corrals generally drains towards the south (see photo 1), with most stormwater directed to the pond located in the middle of the facility (photo 4), which is the first in a series of ponds. In the event the middle ponds fill up, water will flow over a spillway (photo 5) to the central-southern pond (photo 6). Operators noted that in 2009 there was sufficient rainfall for the middle ponds to overflow into the central-southern pond (photo 7). In the event the central-southern pond fills, operators have the ability to pump water to the southeastern pond. The southeastern pond receives runoff only from the eastern edge of the facility and will generally have capacity in the event pumping is needed. Operators stated they have never needed to pump to the southeastern pond.

Photo 1: Overview – (google image)

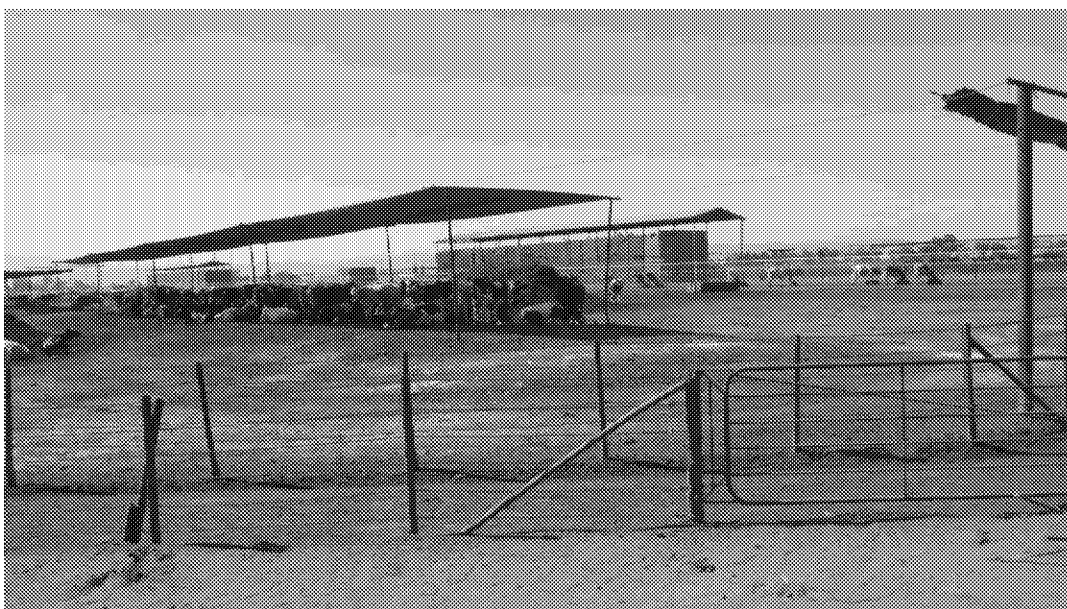
Photo 2: Corrals

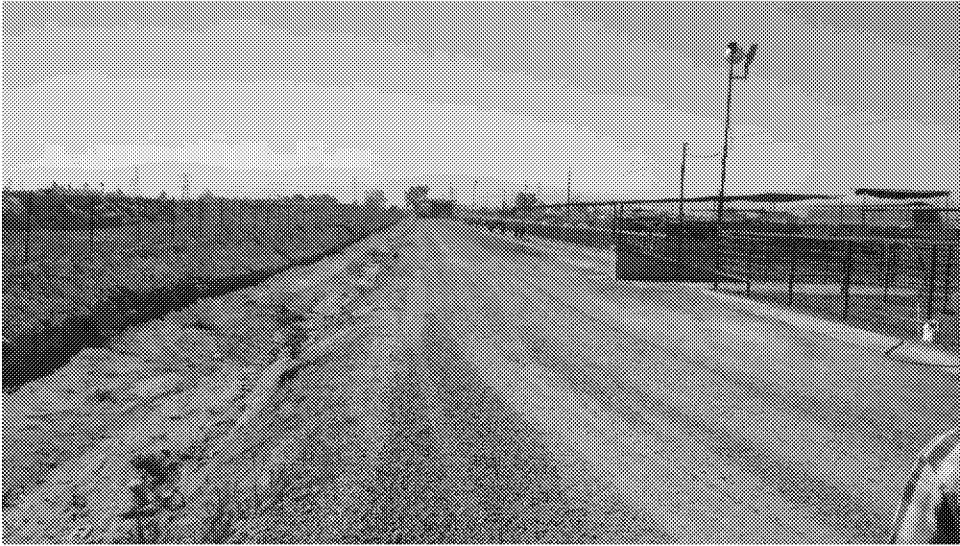
Photo 3: eastern boundary looking south. Drainage ditch conveys stormwater from street past property.

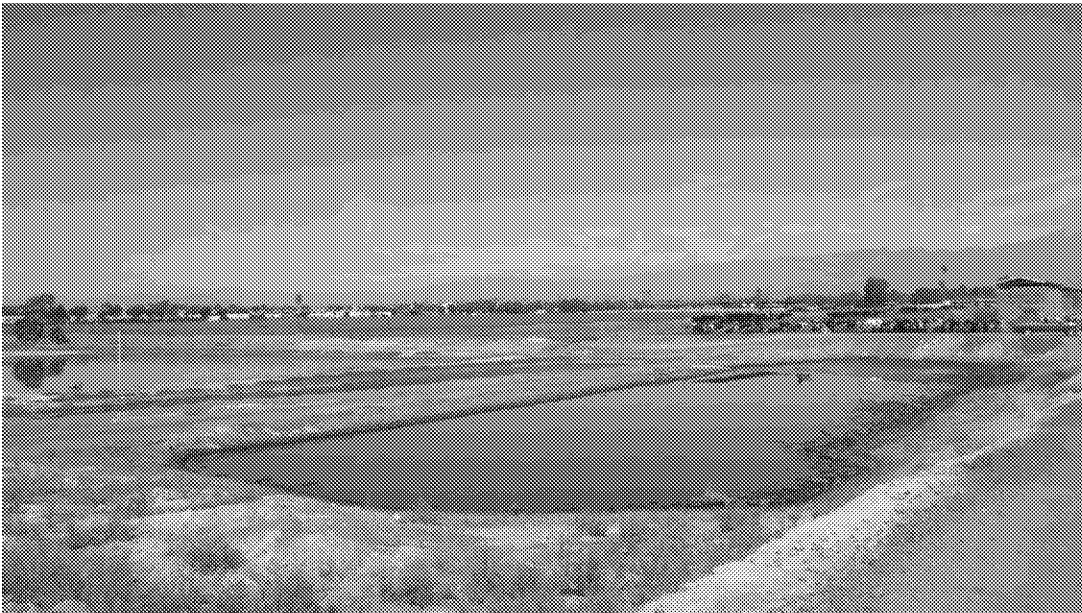
The 2 southern ponds were dry. The middle ponds each held several feet of wastewater. During the inspection, wastewater was observed flowing into the middle pond.

Photo 4: middle ponds

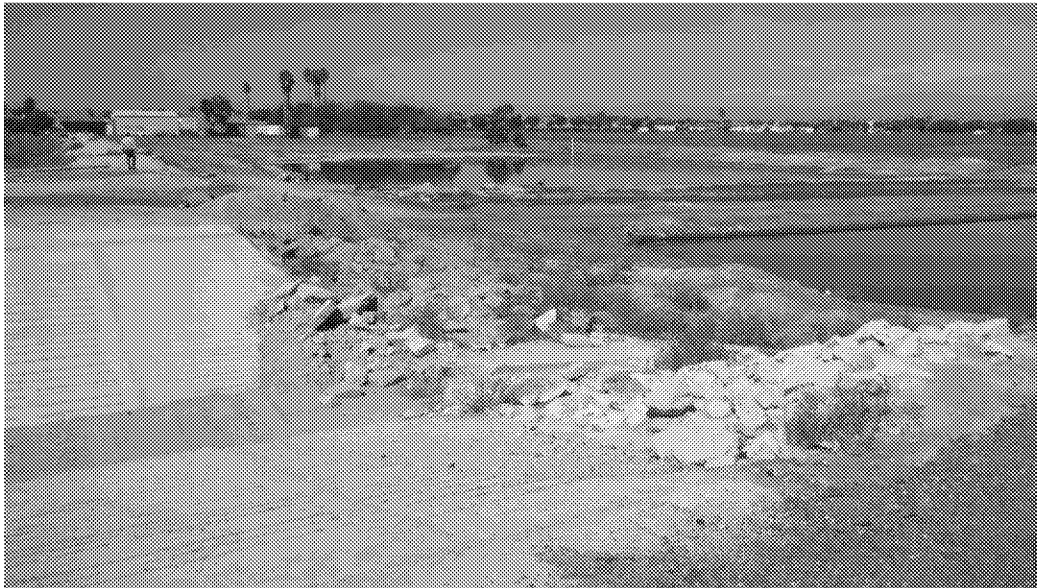
Photo 5: Spillway from middle ponds

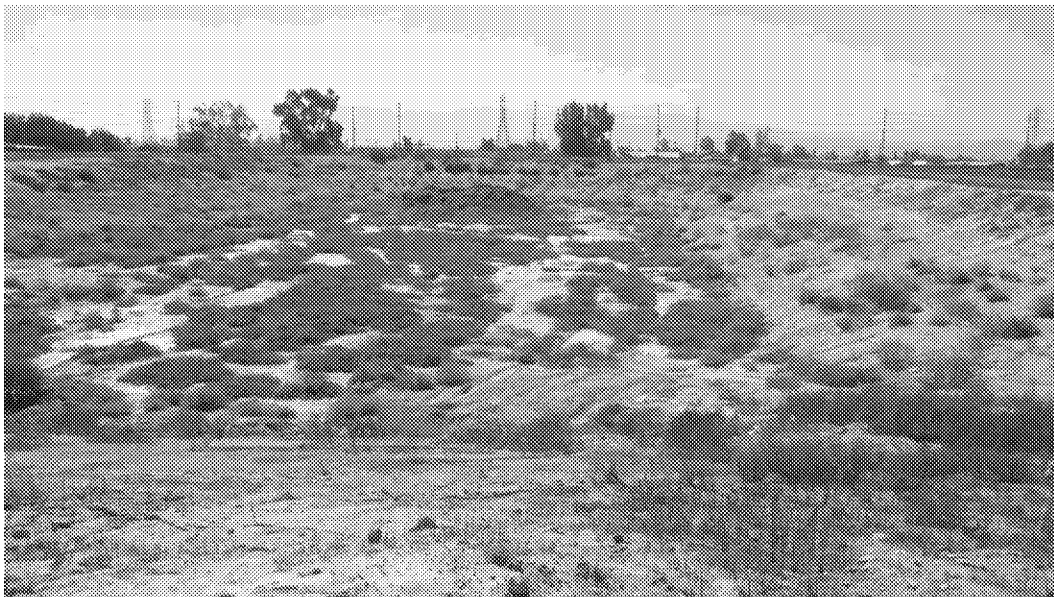
Photo 6: southern central pond

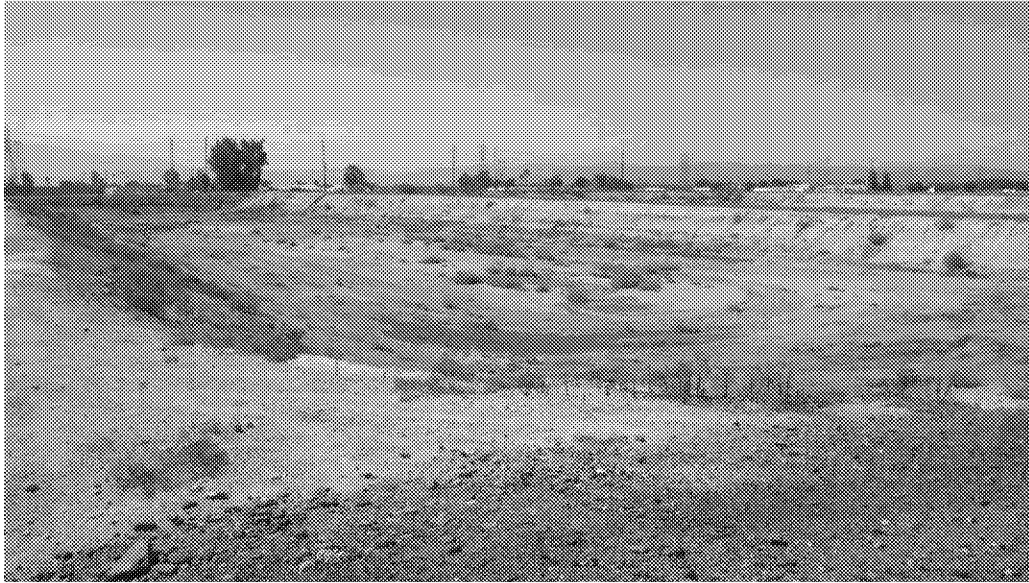
Photo 7: Southeastern pond

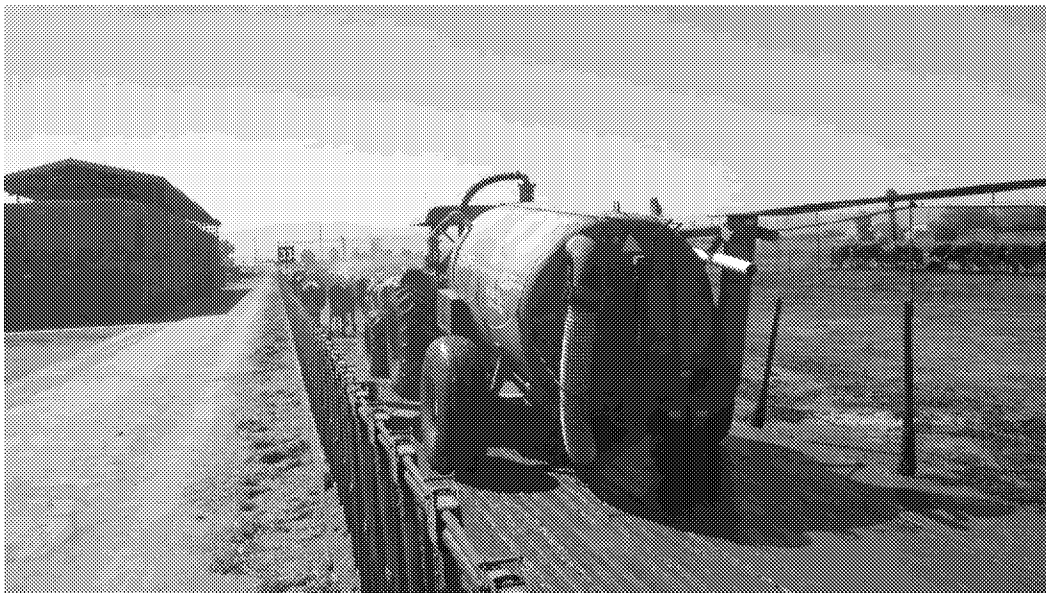
Photo 8: cleaning concrete areas of corral
